**FORT DEVENS
FINAL REMEDIAL
INVESTIGATION
FOR GROUP 2 & 7 SITES**

**FINAL
REMEDIAL INVESTIGATION REPORT
AREA OF CONTAMINATION (AOC) 41**

February 1996

**ABB Environmental Services, Inc.
Portland, ME
Project No. 07053-15**

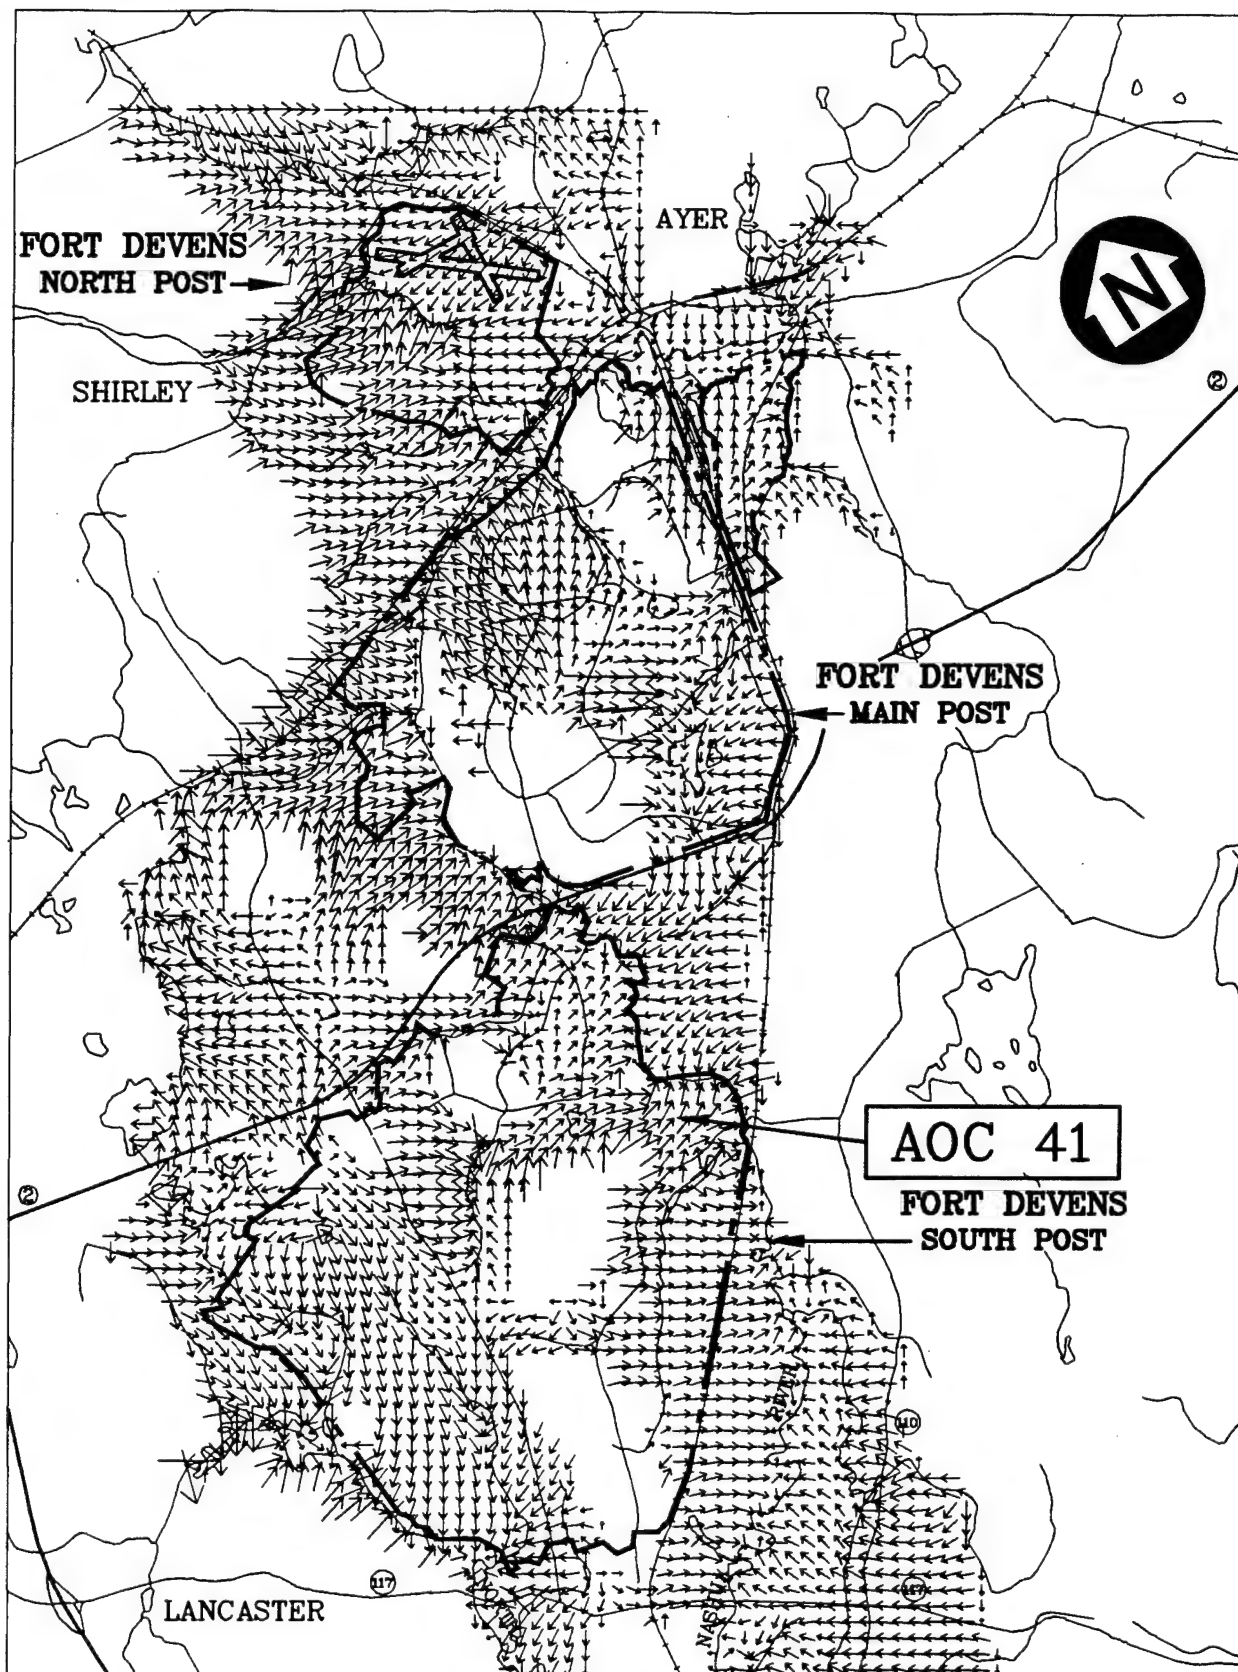
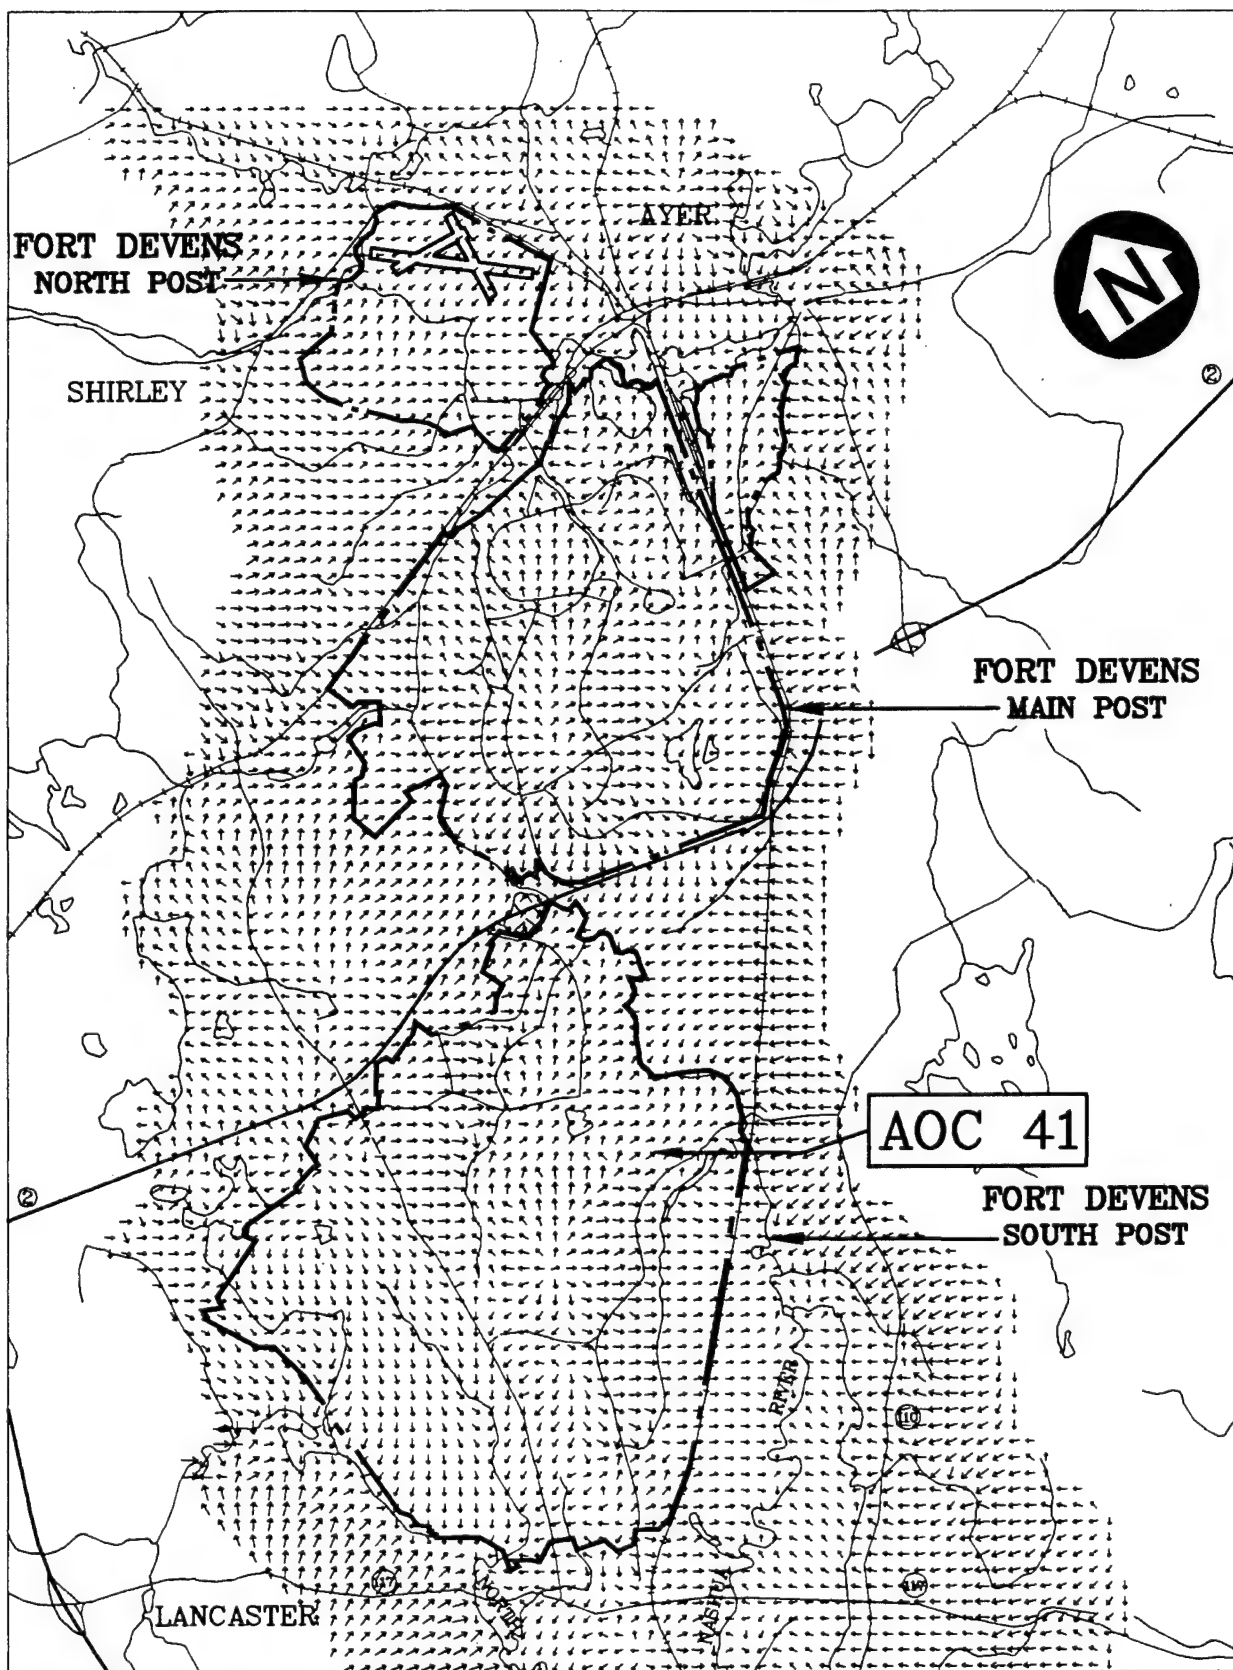
SOURCE:
DRAFT FINAL GROUNDWATER FLOW MODEL AT FORT DEVENS, MA,
ETA, INC. OCTOBER 30, 1992.

GROUNDWATER FLOW VECTORS

In Figure 2-5, the zones of highest transmissivity are found in areas of thick glacial meltwater deposits on the North and Main Posts, and these encompass the Sheboken, Patton, and McPherson production wells and the largely inactive Grove Pond well-field. The zones of lowest transmissivity are associated with exposed till and bedrock and are located on the Main Post surrounding Shepley's Hill and between Jackson Gate and the parade ground, and on the South Post at Whittemore Hill and isolated areas to the north and west.

According to ETA, in the absence of pumping or other disturbances, groundwater recharge occurs in upland areas (e.g., the high ground on the Main Post between Queenstown, Givry, and Lake George Streets, and on the South Post the area around Whittemore Hill). The groundwater flows generally from the topographic highs to topographic lows. It discharges in wetlands, ponds, streams, and directly into the Nashua River. Groundwater discharge maintains the dry-weather flow of the rivers and streams. However, the groundwater flow model does indicate that surface water from New Cranberry Pond is recharging groundwater and flowing north-northeast in the vicinity of AOC 41.

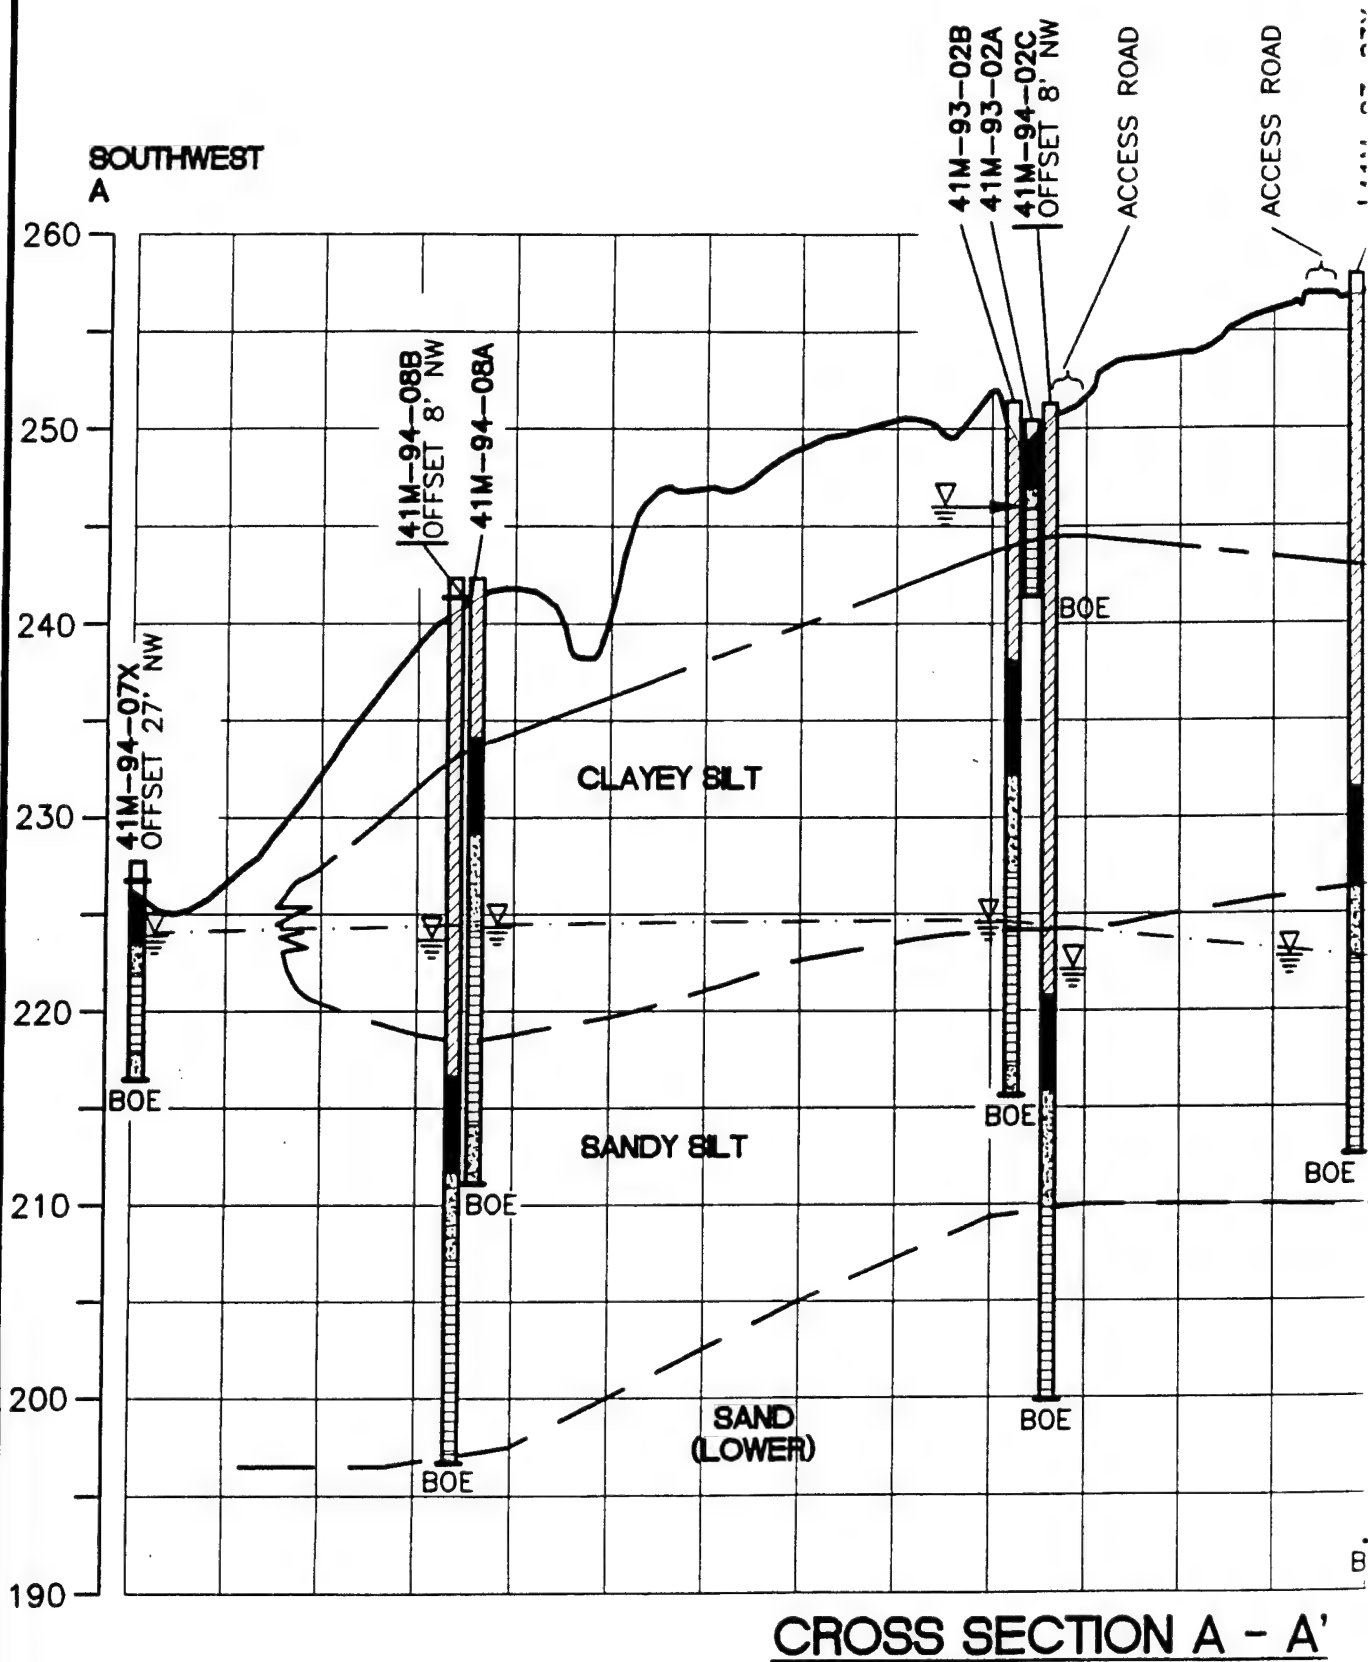
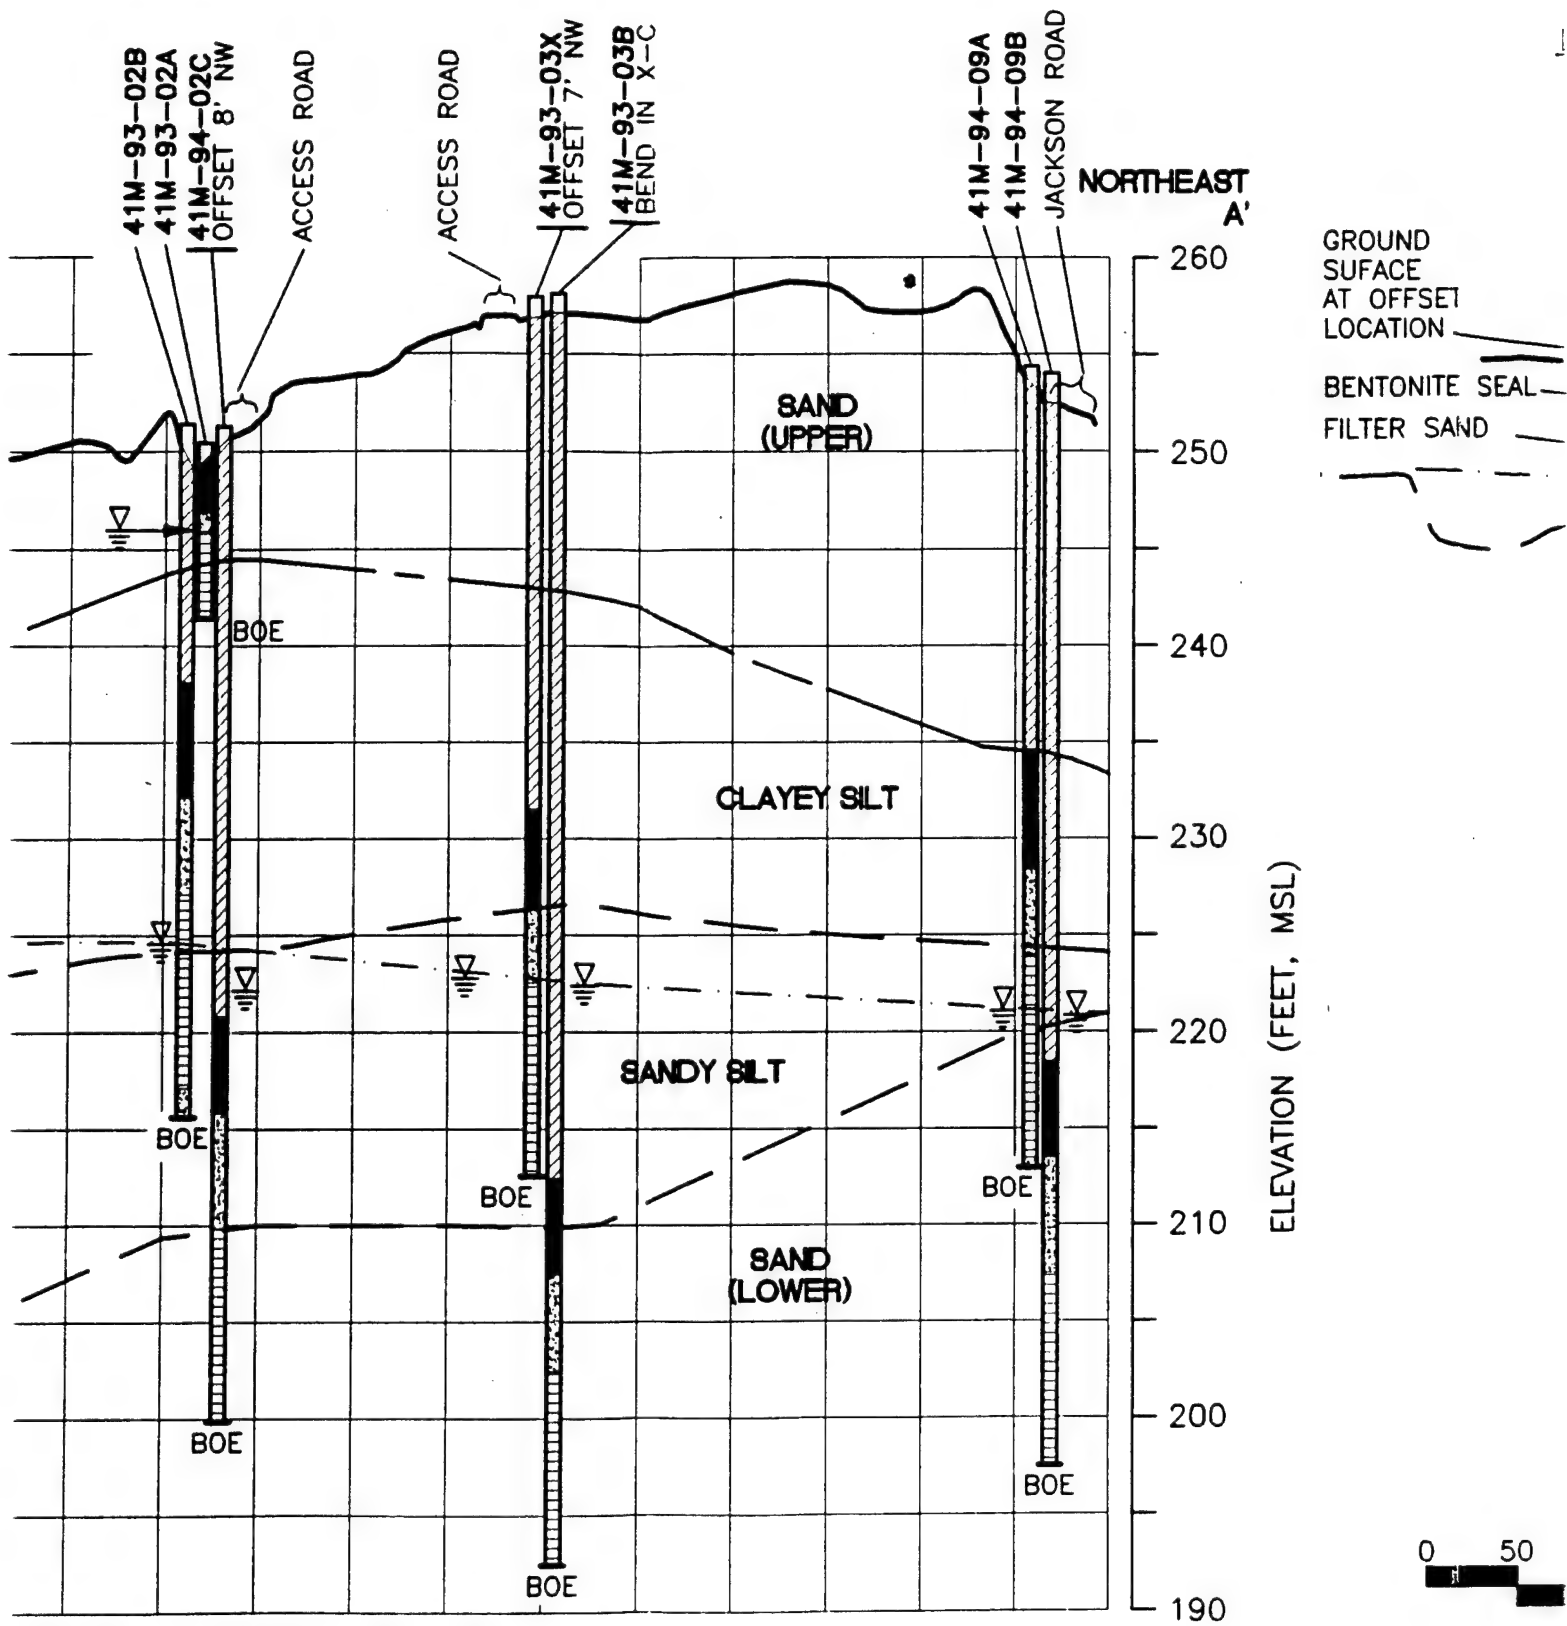
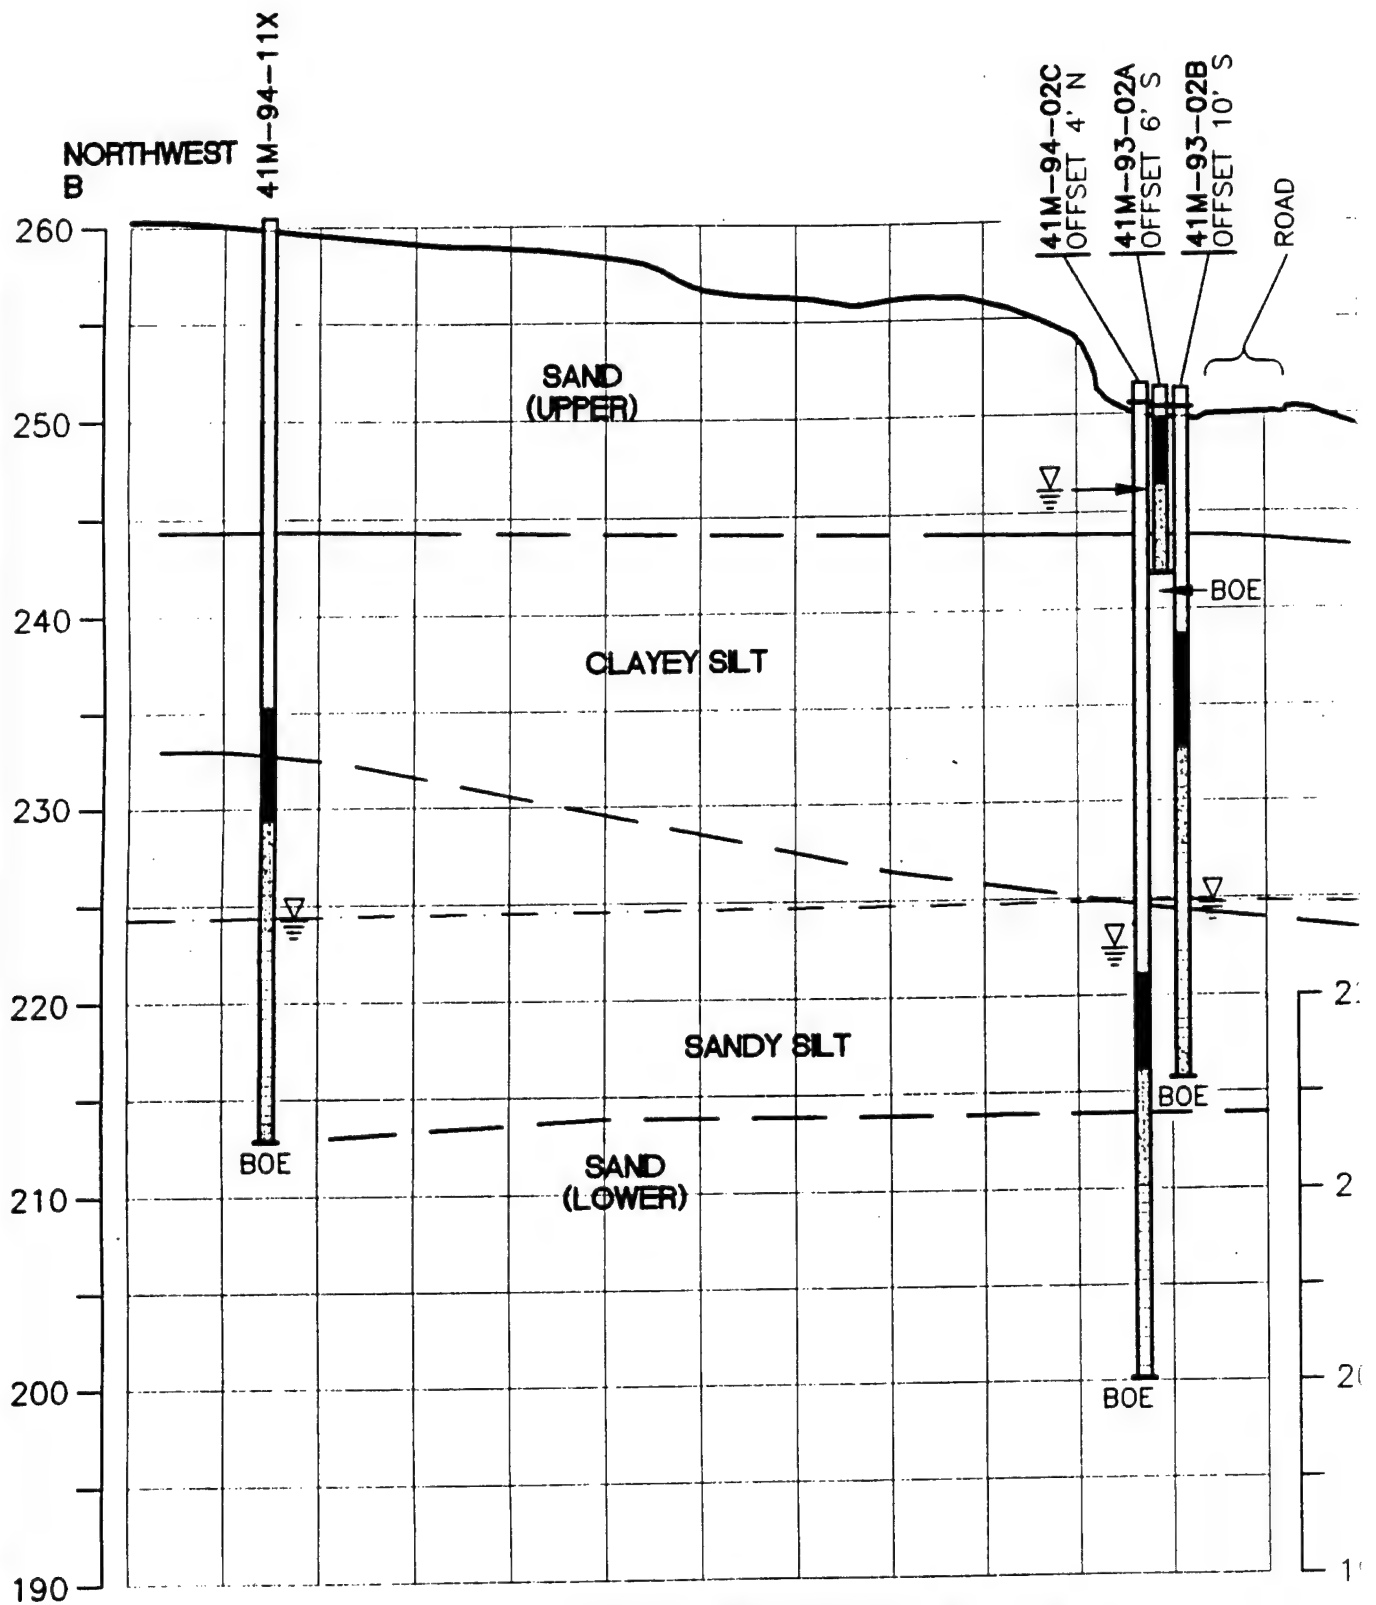
1. FOR ORIENTATION OF CROSS SECTION SEE FIGURE 6-1.
2. GEOLOGIC CONDITIONS BETWEEN WELLS ARE AN INTERPRETATION OF AVAILABLE DATA. ACTUAL CONDITIONS MAY VARY.

CROSS SECTION A - A'

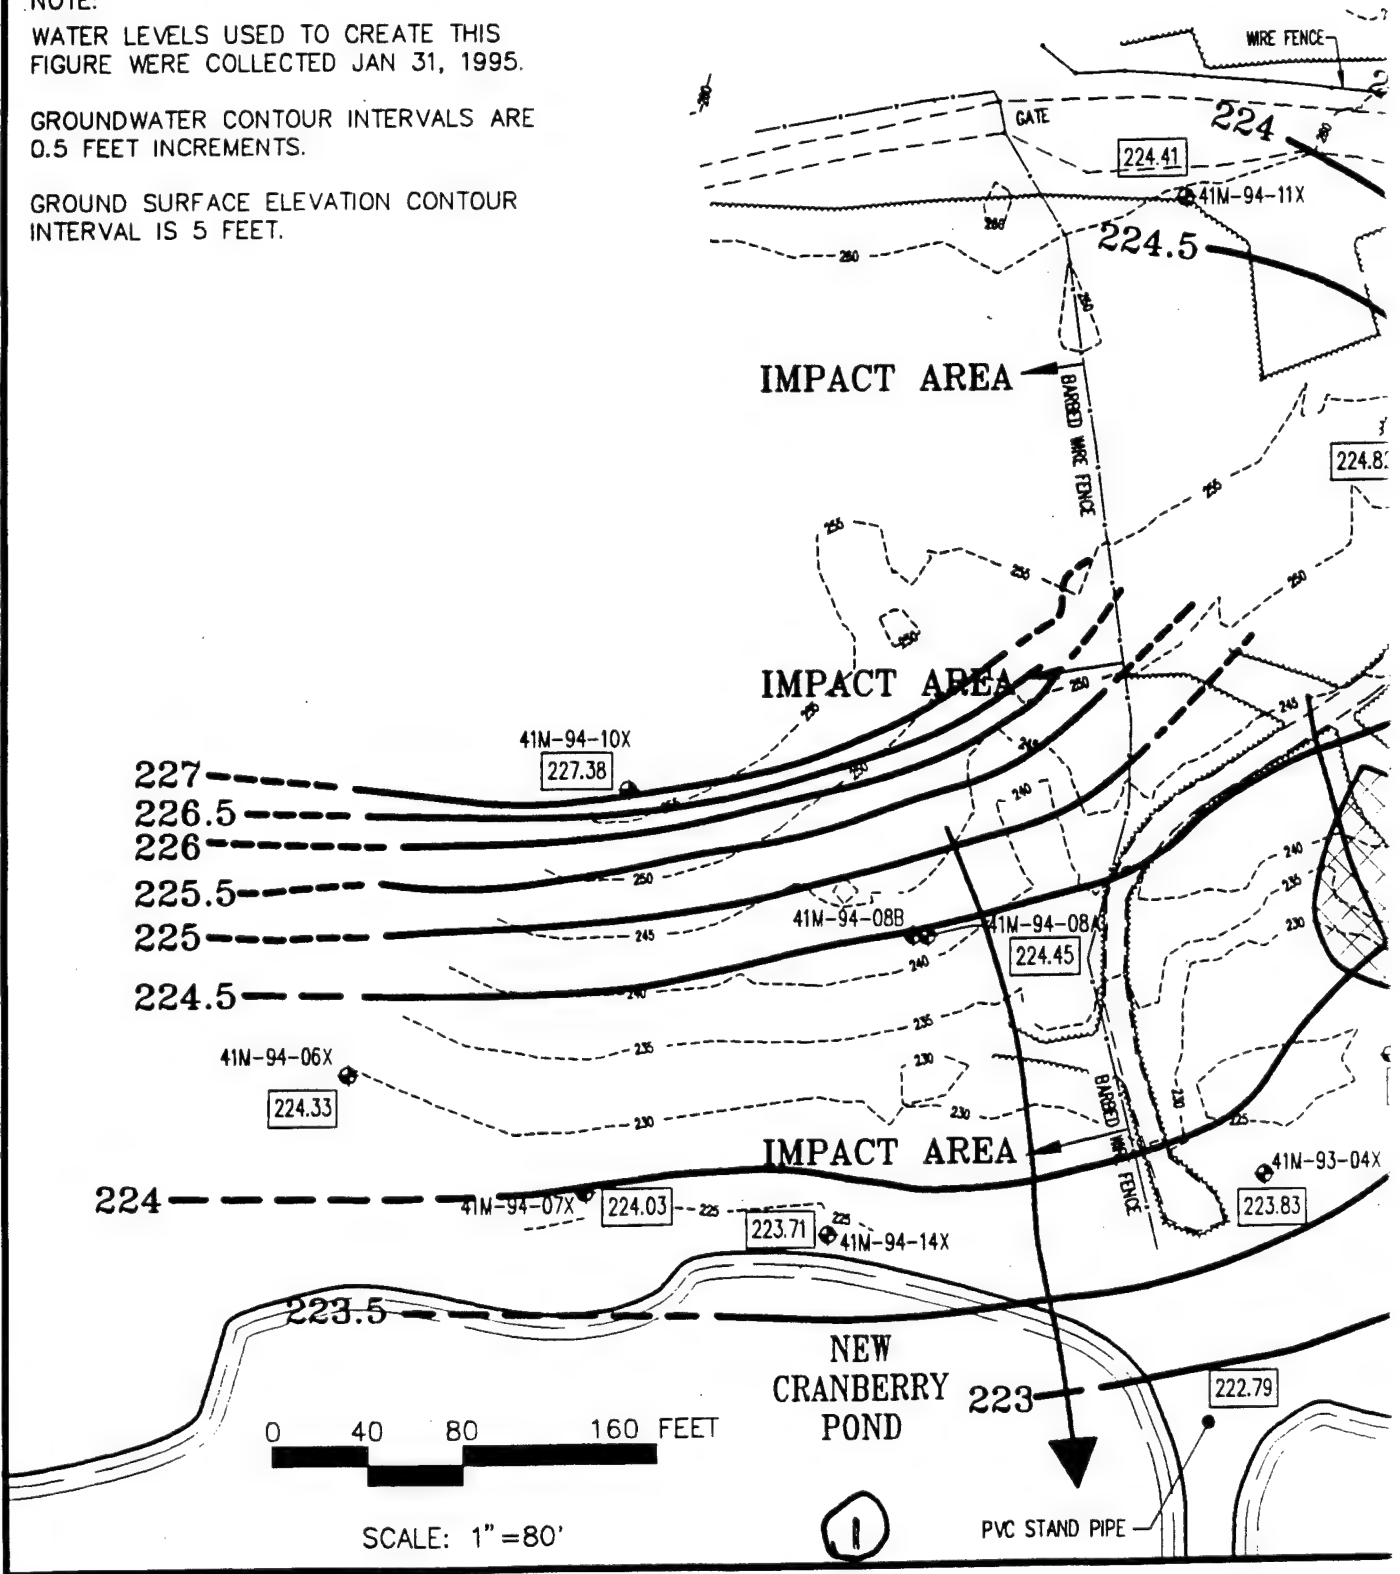
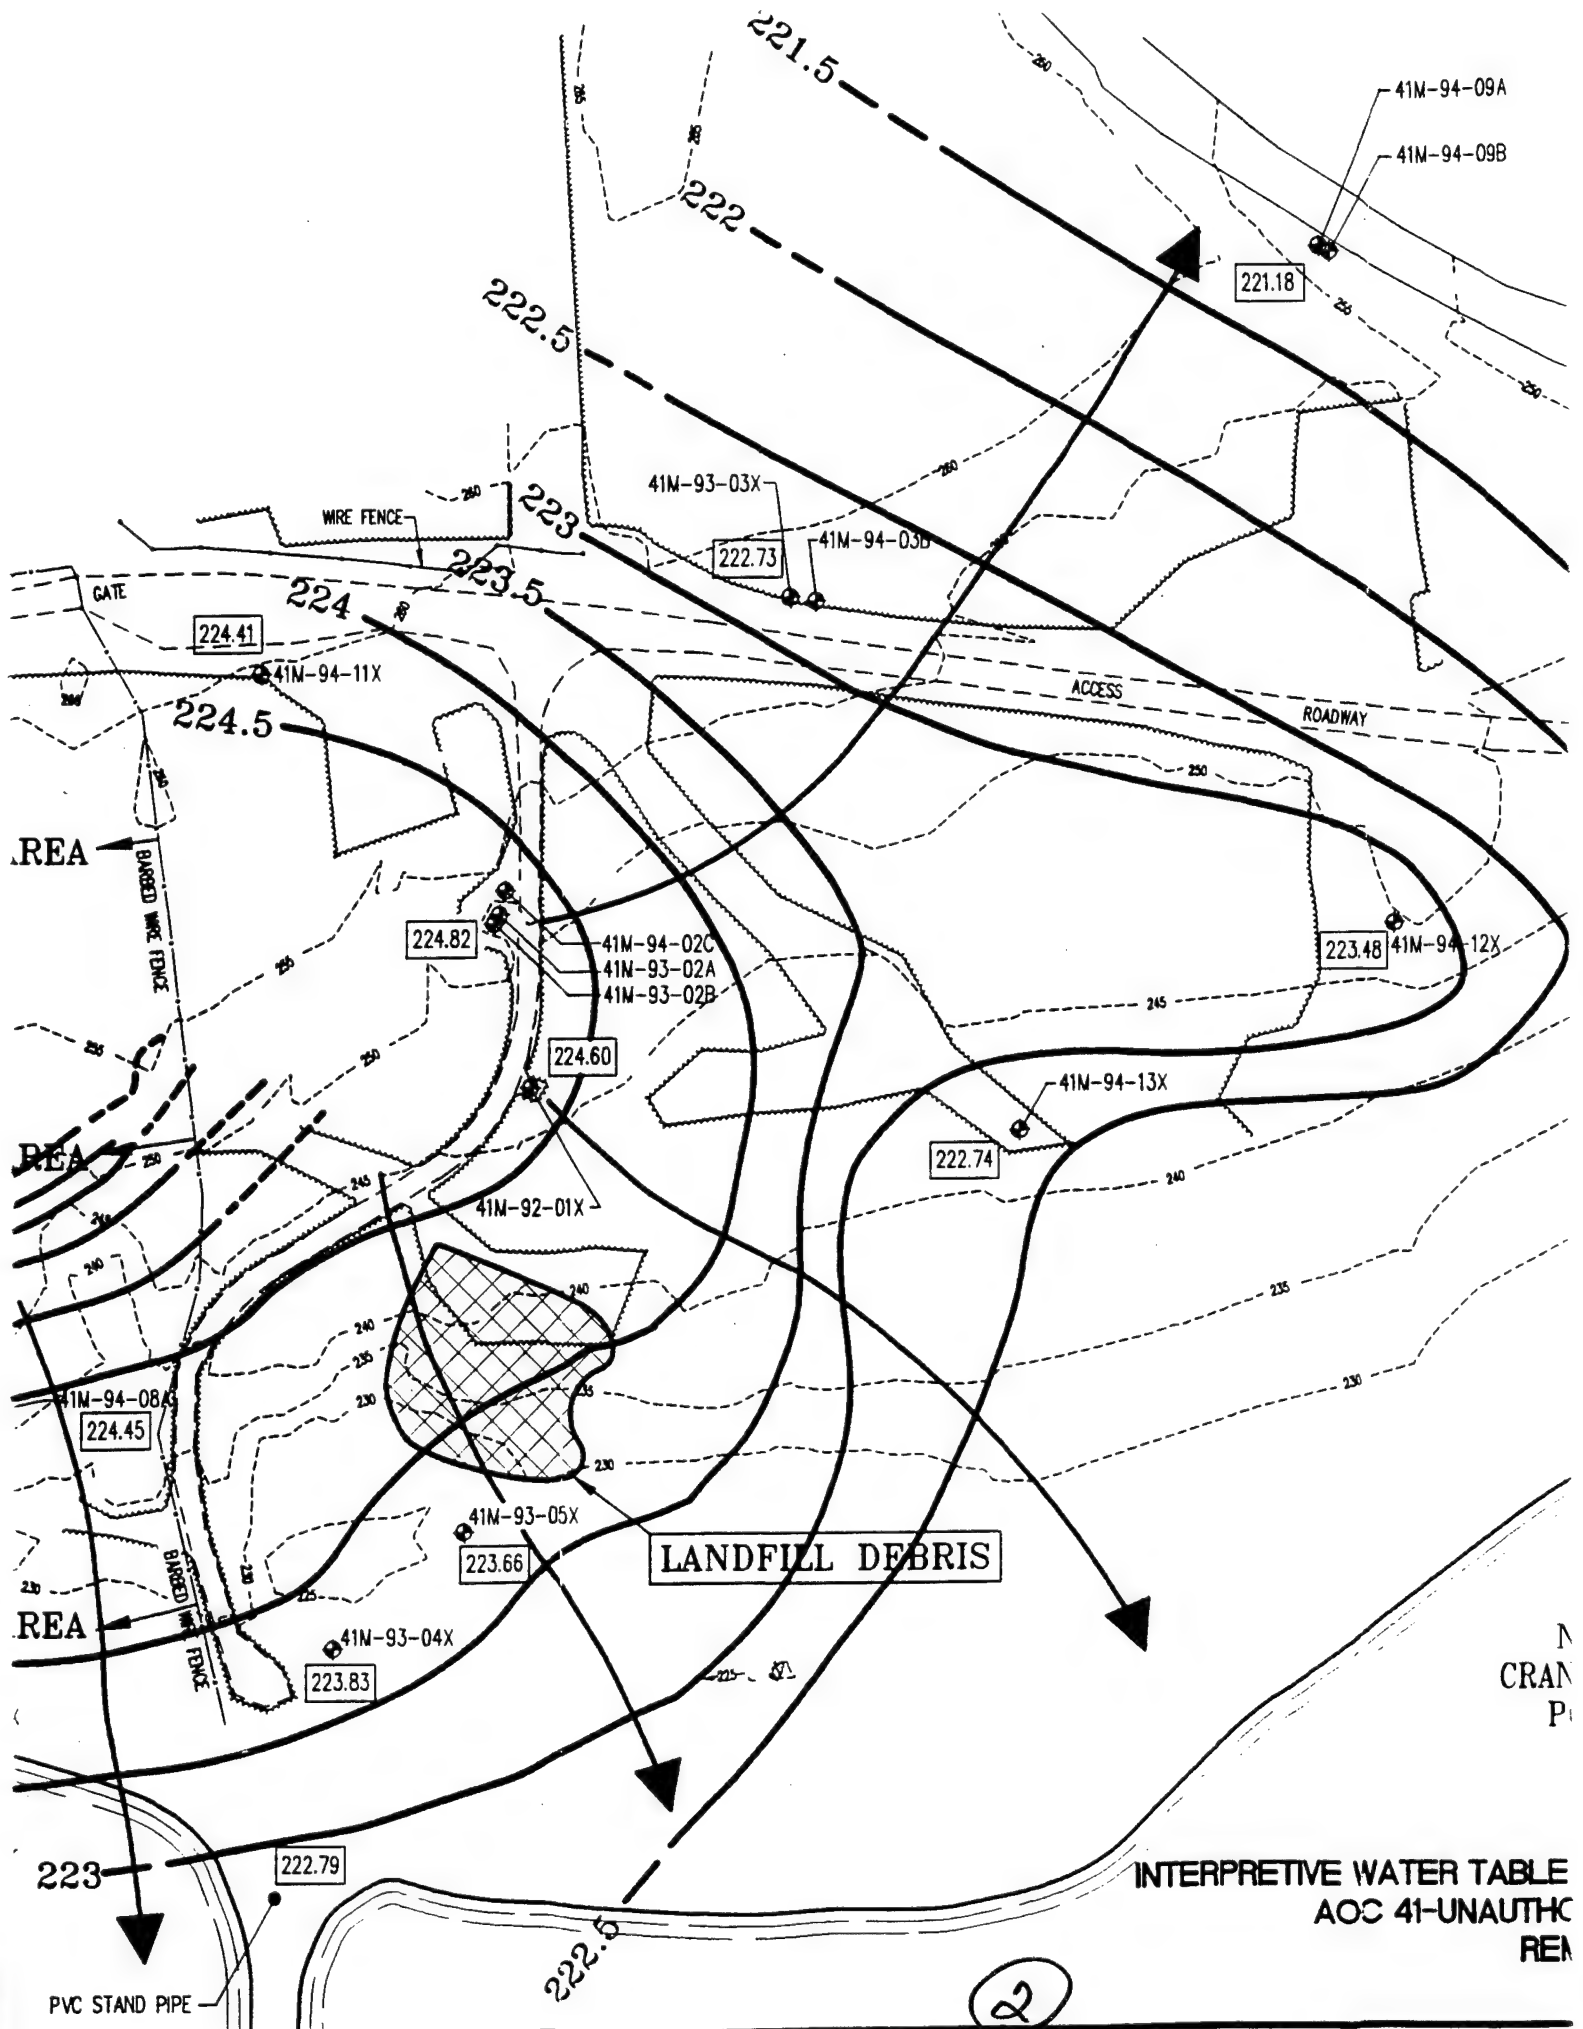
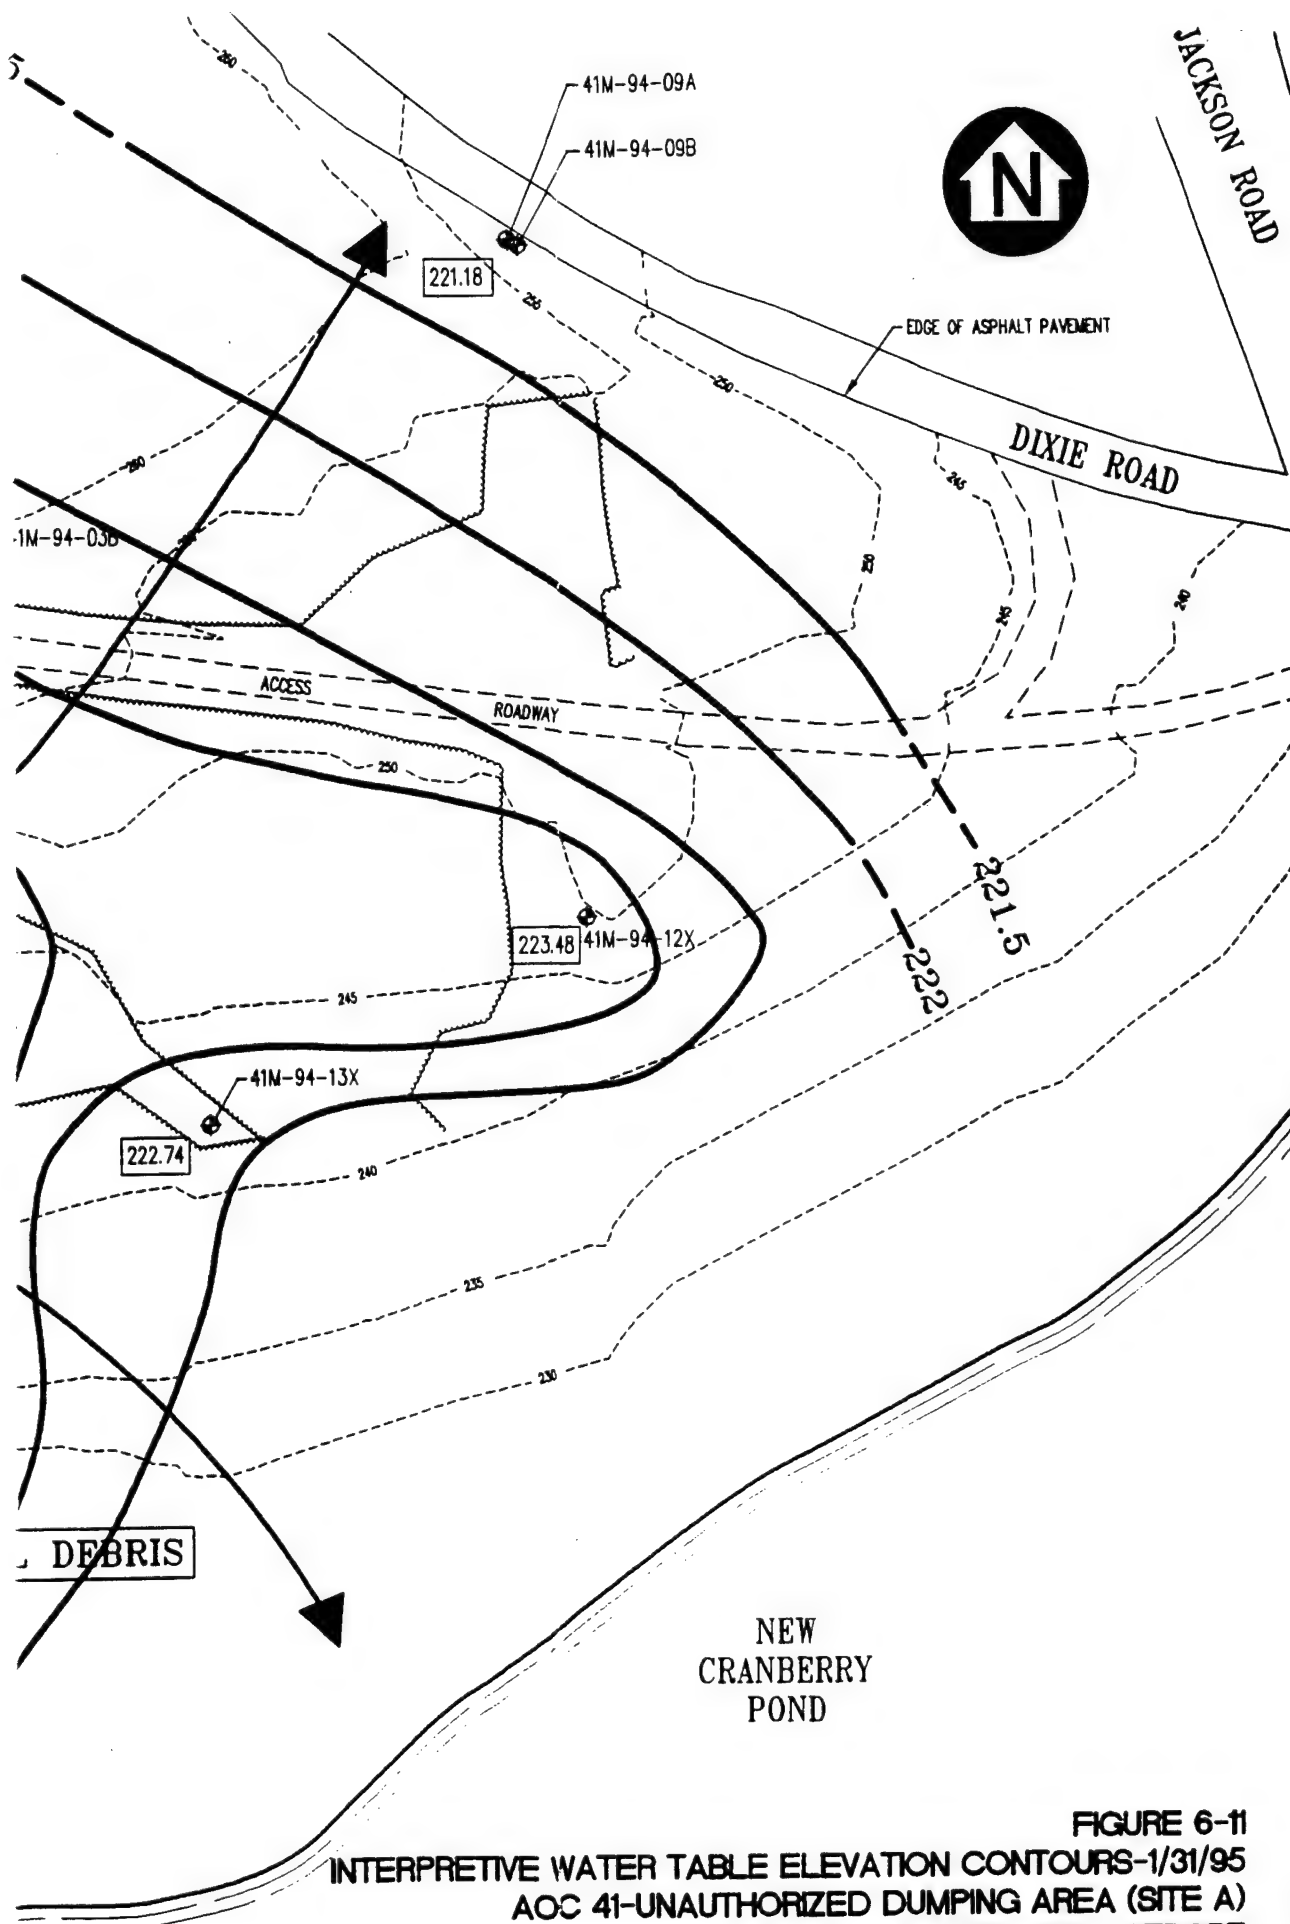
FIGURE 6-11
INTERPRETIVE WATER TABLE ELEVATION CONTOURS-1/31/95
AOC 41-UNAUTHORIZED DUMPING AREA (SITE A)
REMEDIAL INVESTIGATION REPORT
FORT DEVENS, MA

GROUNDWATER CONTOUR INTERVALS ARE 0.5 FEET INCREMENTS.
